C A M B R I D G E
FIRE RESEARCH

REPORT NUMBER
CFR1002031

FIRE RESISTANCE TEST
IN ACCORDANCE WITH BS 476: PART 22: 1987

<p>Summary of test specimen: Partially insulated single acting glazed double leaf timber doorset.</p> <p>Left leaf size: 2100 high x 927 wide x 54 thick overall Right leaf size: 2100 high x 926 wide x 54 thick overall</p>
---	--

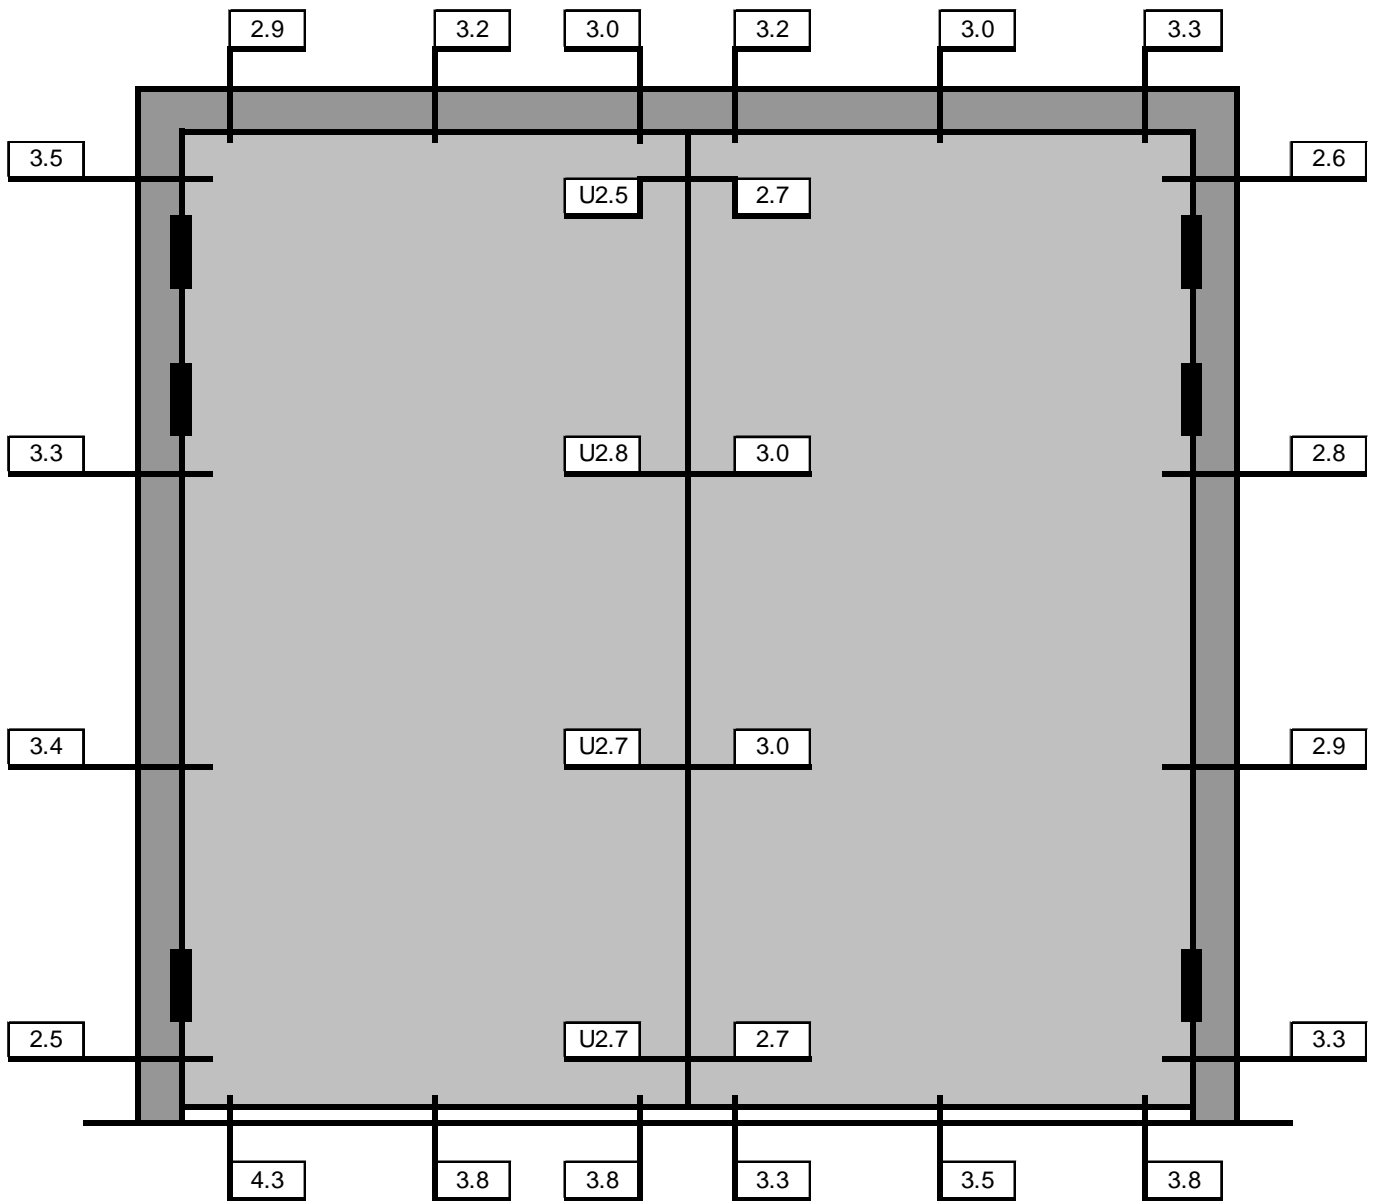
The gap between the leaf edges and the frame, between the meeting stiles and at the threshold was measured on the exposed face prior to the start of the test. The unexposed face gap was also measured at the meeting stiles. The following figure shows the position at which the measurements were made and the recorded gap (mm) at those positions. The 'U' indicates the measurement of the gap between the meeting stiles from the unexposed face.

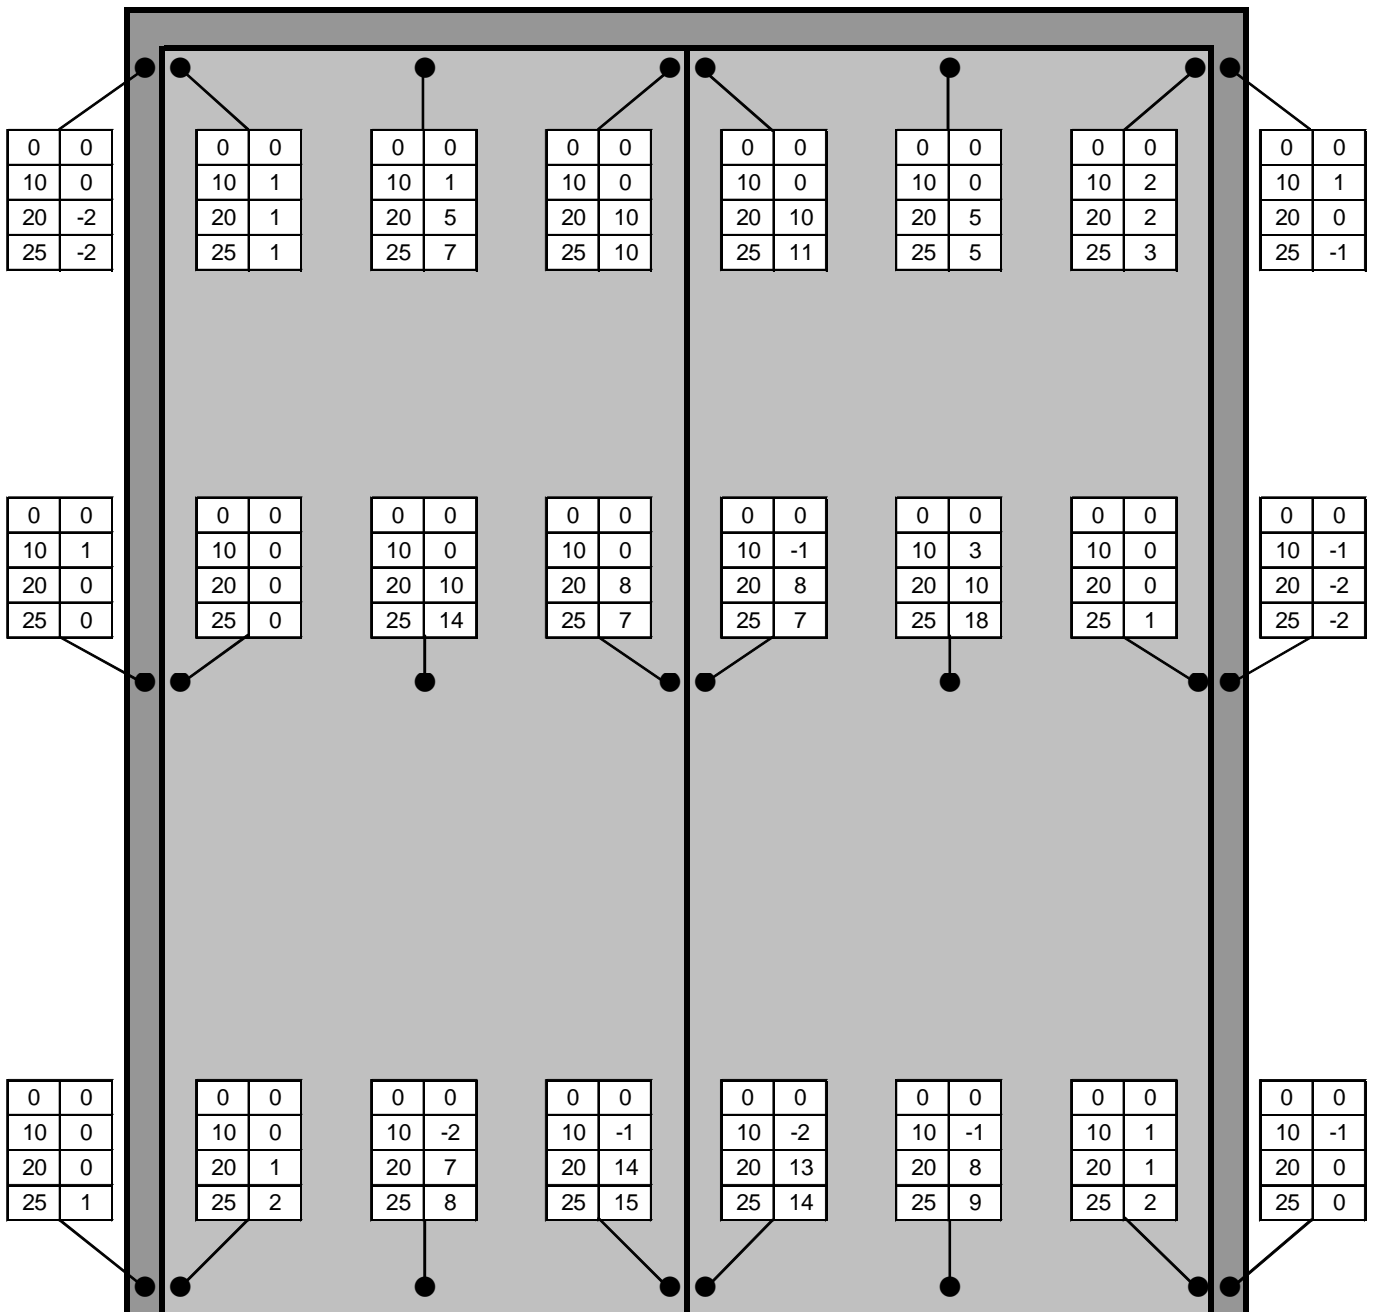
Taut stainless steel wires were anchored horizontally across the unexposed face of the specimen such that any deflection experienced by the test specimen could be measured. One wire was positioned 25 mm vertically below the head of the leaves, the second at mid-height and the third 25 mm vertically above the threshold. The following figure shows these positions with the elapsed time (minutes) in the left hand column and the recorded deflection (mm) in the right hand column. Positive values indicate deflection towards the heating conditions of the test. The relevance of the measurements should be considered in conjunction with the fact that restraint was applied to the leaves at 16 minutes.

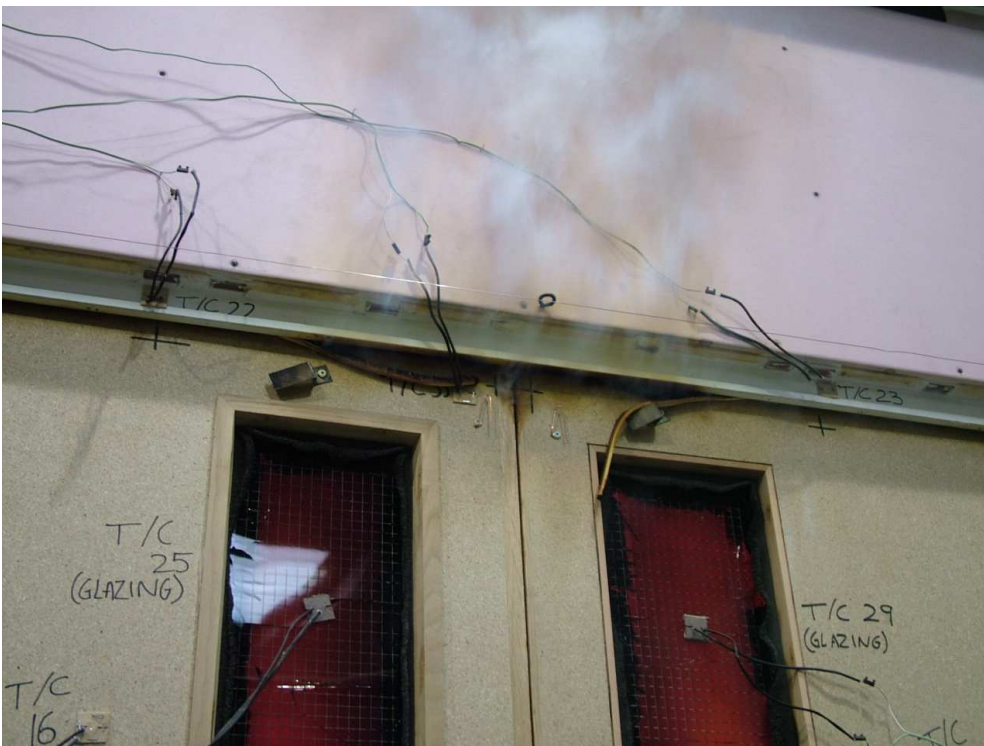
Photo 2.2.4 – After 17 minutes.

17:00	U	The intumescent across the head of both leaves has partially detached.
