# test report

The fire resistance performance of two fully insulated, single-acting, single-leaf doorsets, in accordance with BS 476: Part 22: Clause 6.

164432

**Sauerlander  
Spanplatten GmbH**  
Postfach 5553  
59805 Arnsberg  
Germany

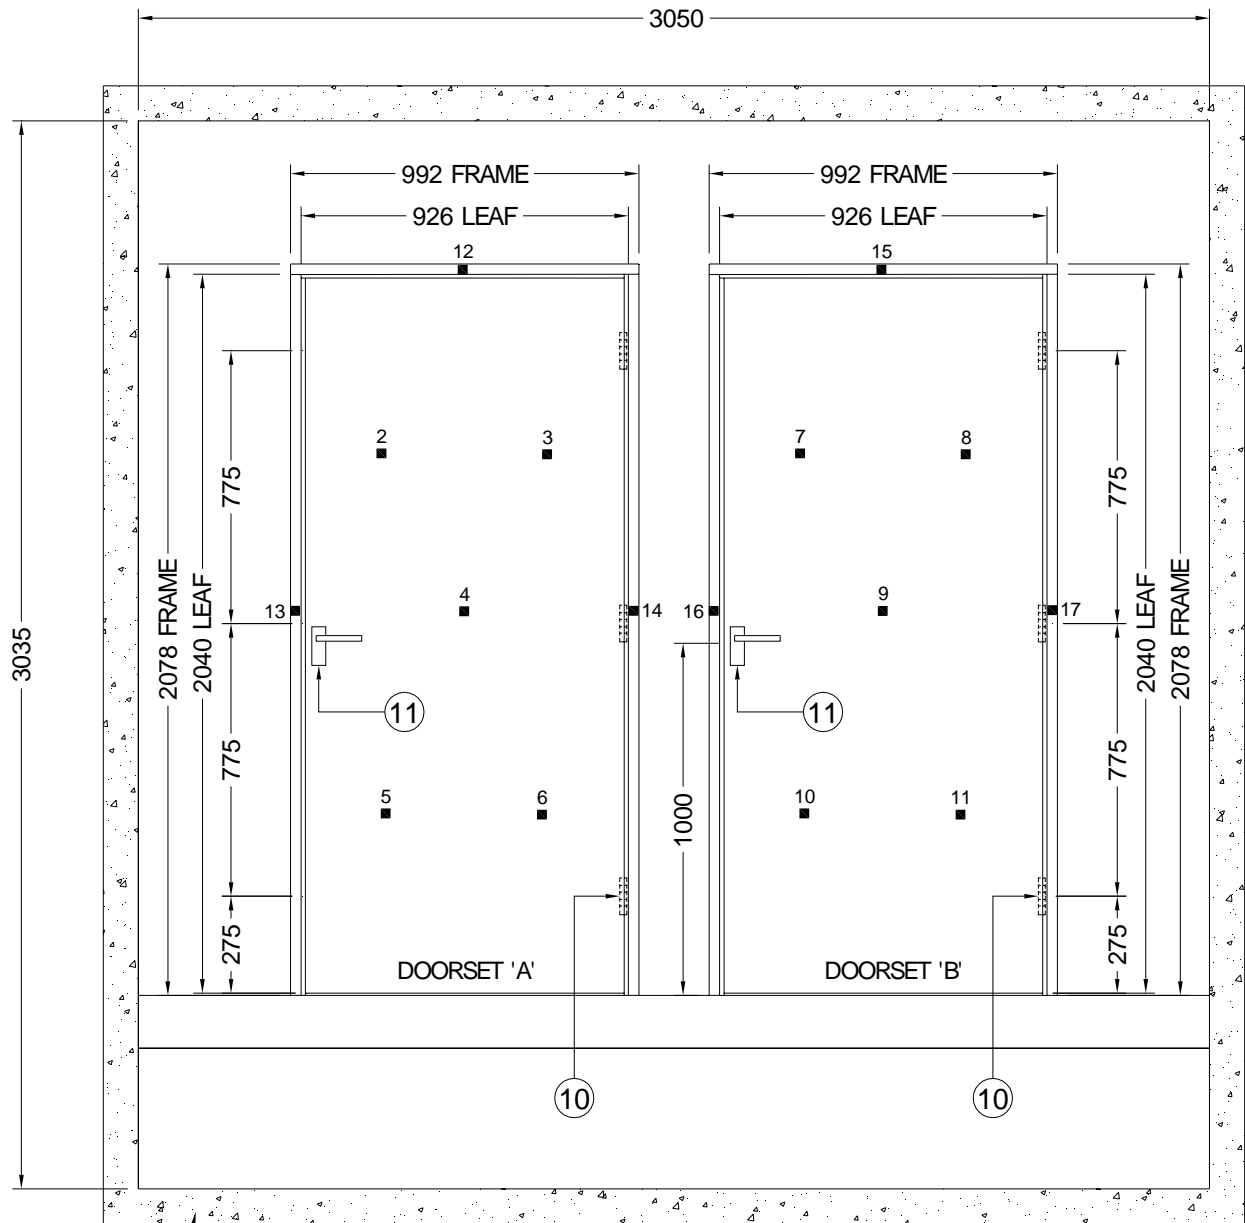
**Figure 1- General Elevation of Test Specimens**

SPECIMEN RESTRAINT FRAME

- POSITIONS OF UNEXPOSED FACE THERMOCOUPLES.

SPECIMEN BUILT INTO A MASONRY WALL CONSISTING OF AAC (AUTOCLAVED AERATED CONCRETE) BLOCKWORK WALLS, LINTEL AND BASE, NOMINALLY 150 THICK. BOTH DOOR LEAVES OPEN TOWARDS THE HEATING CONDITIONS OF THE TEST.

<b>General</b>	The instrumentation was provided in accordance with the requirements of the Standard.
<b>Furnace</b>	The furnace was controlled so that its mean temperature complied with the requirements of BS 476: Part 20: 1987, Clause 3.1. using six mineral insulated thermocouples distributed over a plane 100 mm from the surface of the test construction.
<b>Thermocouple Allocation</b>	Thermocouples were provided to monitor the unexposed surface of the specimen and the output of all instrumentation was recorded at no less than one minute intervals as follows:
<b>Thermocouples 2 to 6 Doorset A and 7 to 11 Doorset B</b>	At five positions on each doorset, one approximately at the centre and one at approximately the centre of each quarter section of the doorset.
<b>Thermocouples 12 to 14 Doorset A and 15 to 17 Doorset B</b>	At three positions at the approximate centre of each frame member.  The locations and reference numbers of the various unexposed surface thermocouples are shown in Figure 1.

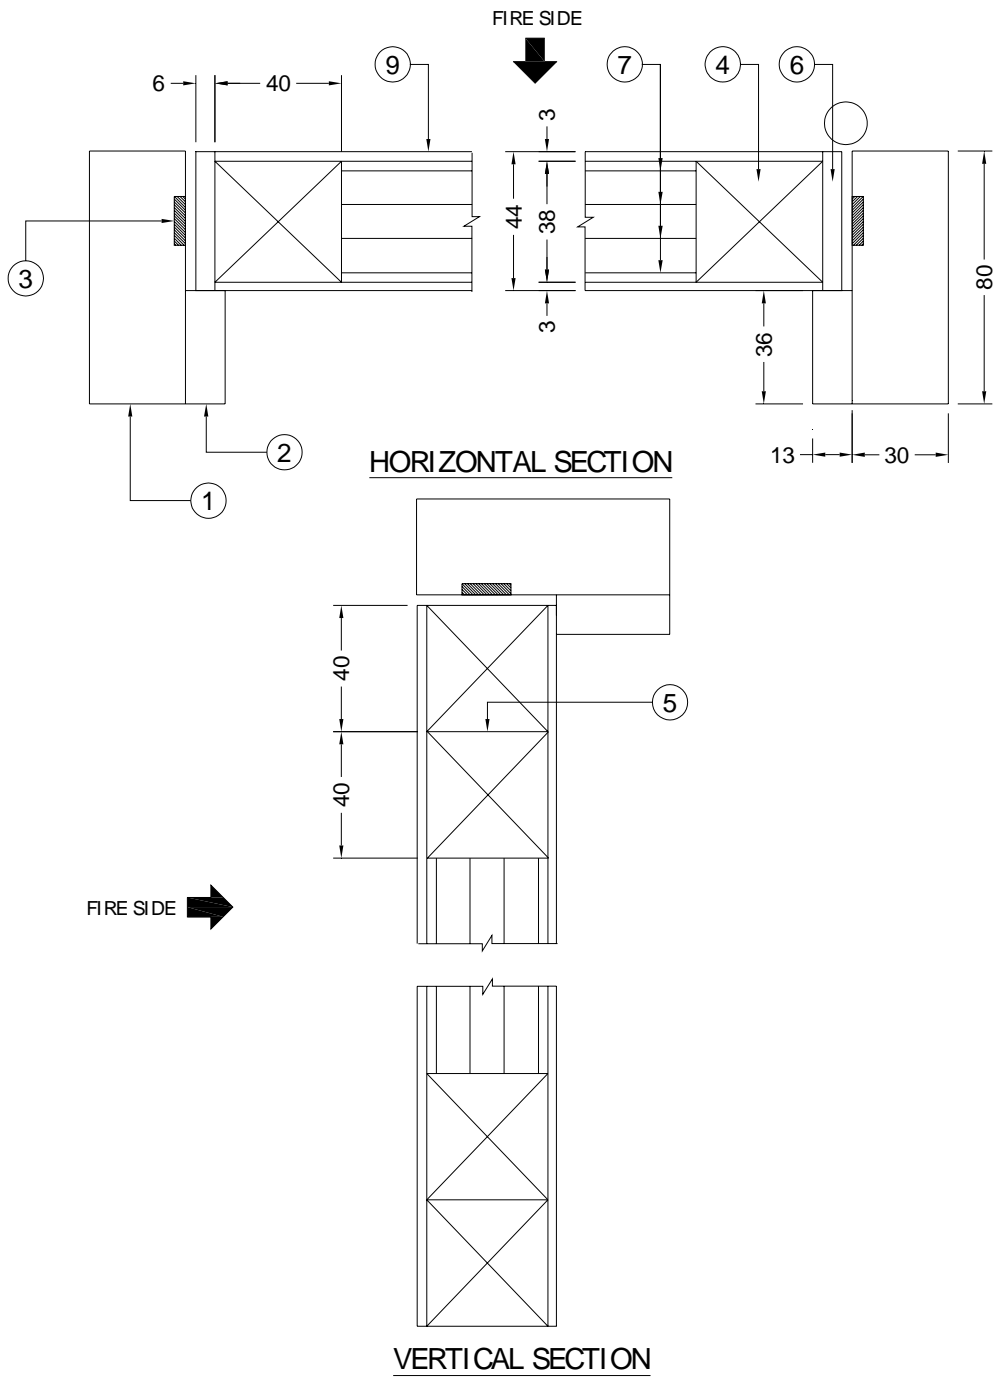
**Figure 2 – Details of Doorset 'A'**

**Door leaf A** comprised an extruded solid board core referenced '38 S3K, a hardwood perimeter framework and 3 mm thick hardboard facings referenced 'Homadur Typ 5'. The leaf was hung within a softwood frame on three steel hinges.

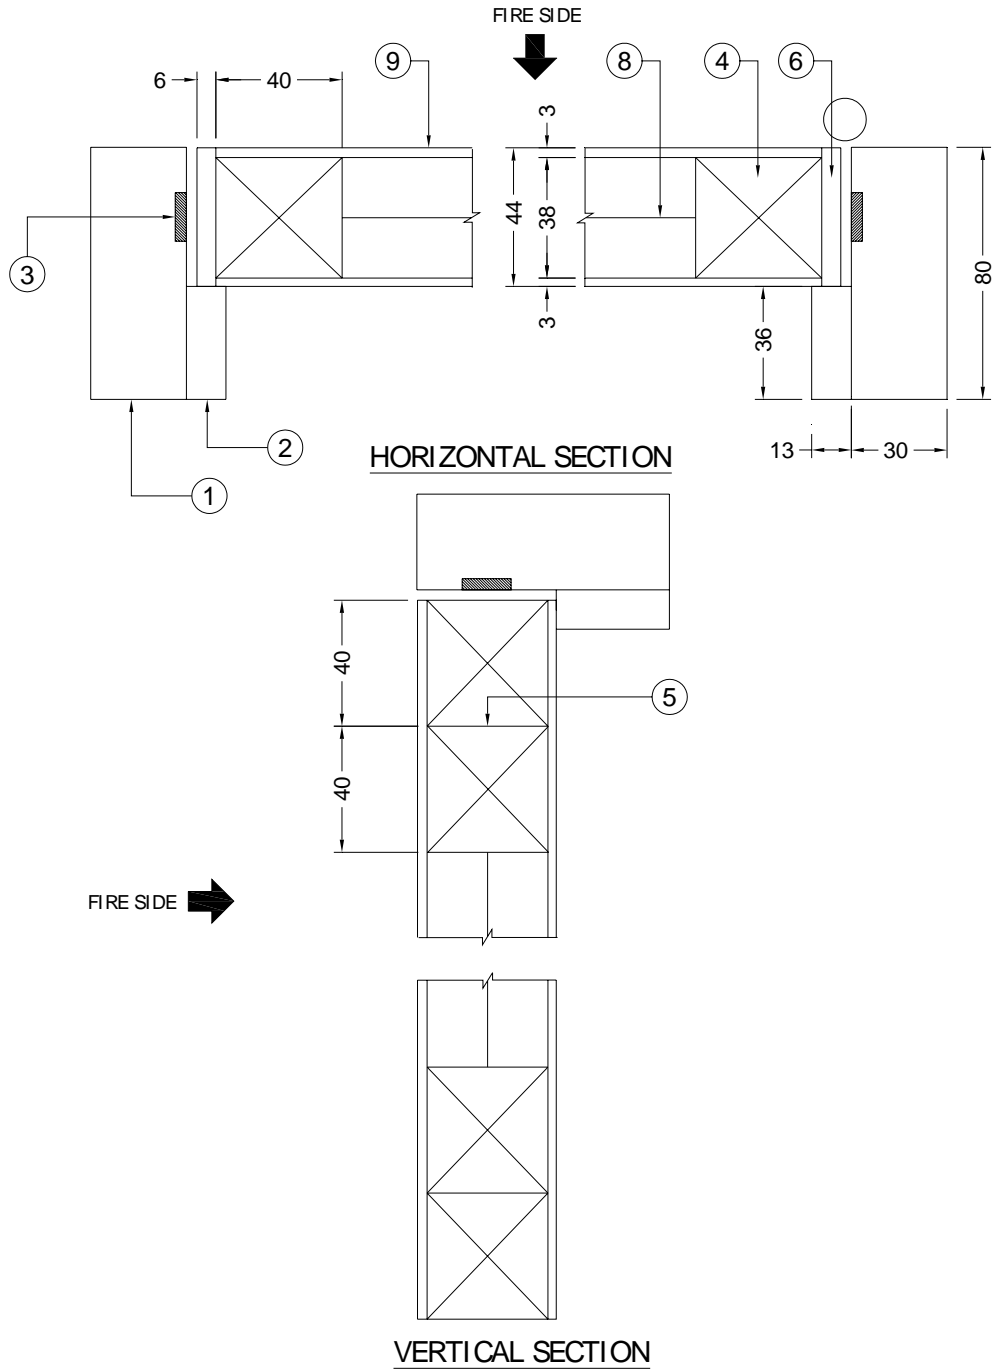
**Figure 3 – Details of Doorset 'B'**

**Door leaf B** comprised an extruded solid board core referenced '38 S2, a hardwood perimeter framework and 3 mm thick hardboard facings referenced 'Homadur Typ 5'. The leaf was hung within a softwood frame on three steel hinges.

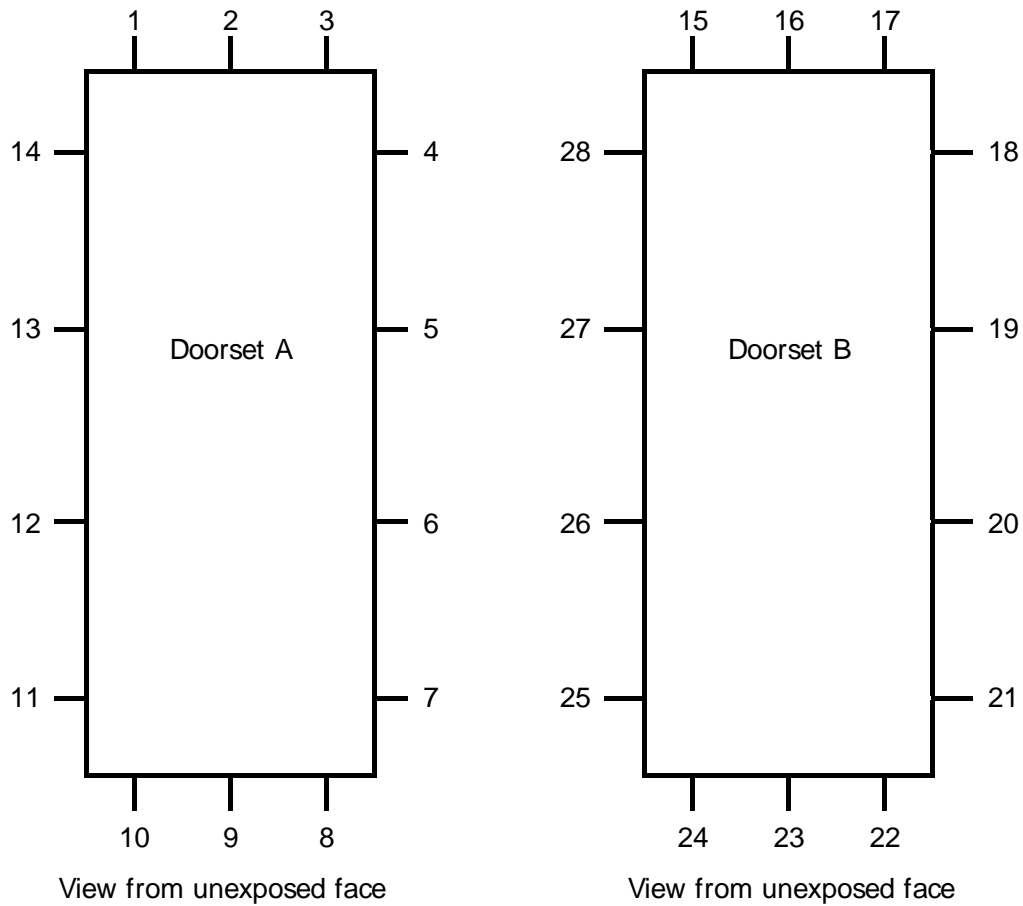
# Doorset Clearance Gaps

Door Ref	Gap Dimension in mm at Positions													
	1	2	3	4	5	6	7	8*	9*	10*	11	12	13	14
A	2.3	1.9	1.8	1.6	1.8	1.6	1.3	5	5	5	2.9	2.7	2.8	3.0
	15	16	17	18	19	20	21	22*	23*	24*	25	26	27	28
B	2.5	2.4	2.3	1.8	1.2	1.1	1.0	5	5	6	3.2	3.3	3.4	3.4
A	Mean		2.0		Maximum			3.0			Minimum			1.3
B	Mean		2.0		Maximum			3.4			Minimum			1.0

\* Dimension not included in calculations

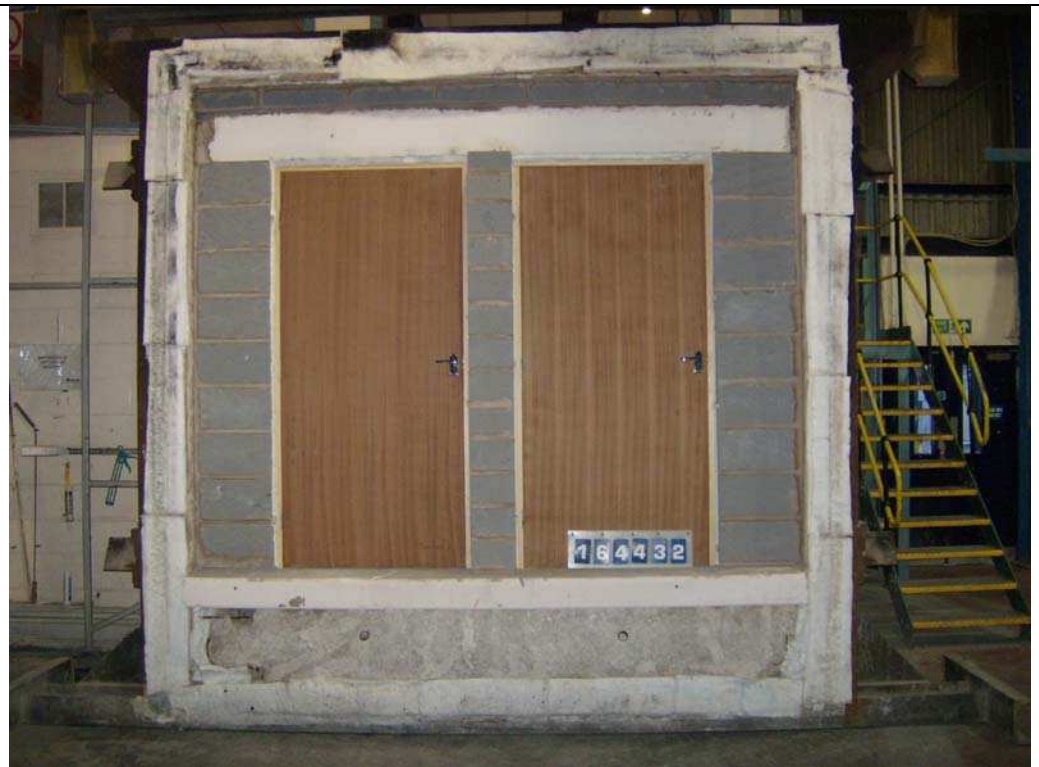
The exposed face of the doorset prior to testing

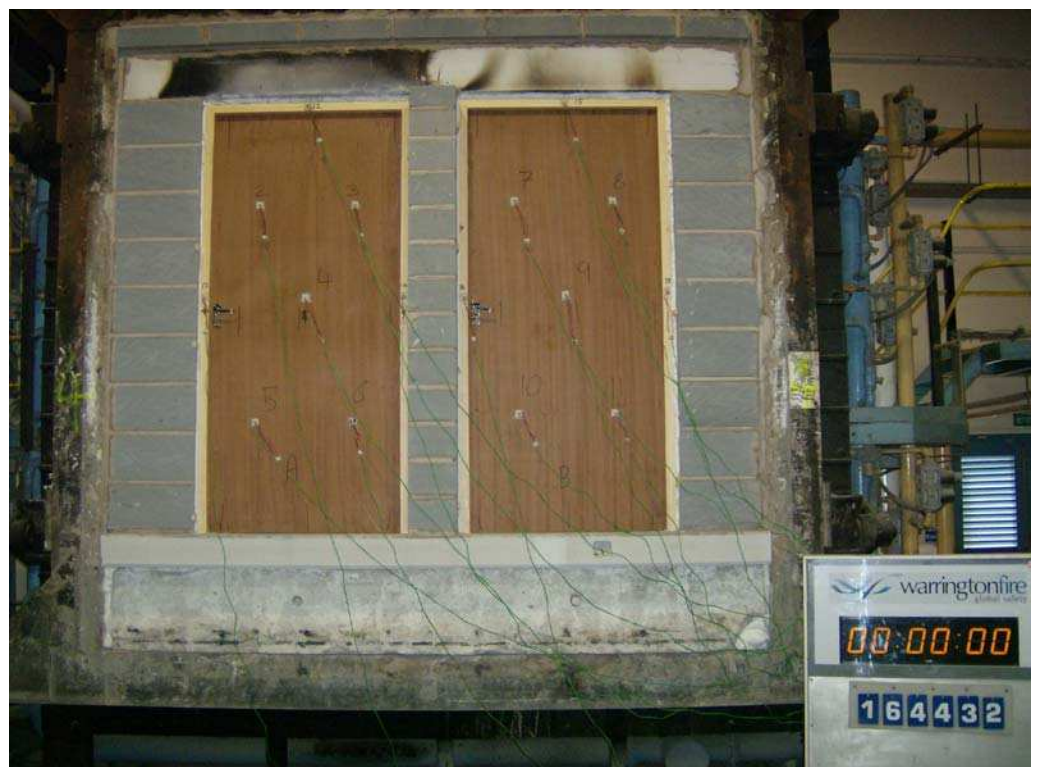
The unexposed face of the doorsets prior to testing

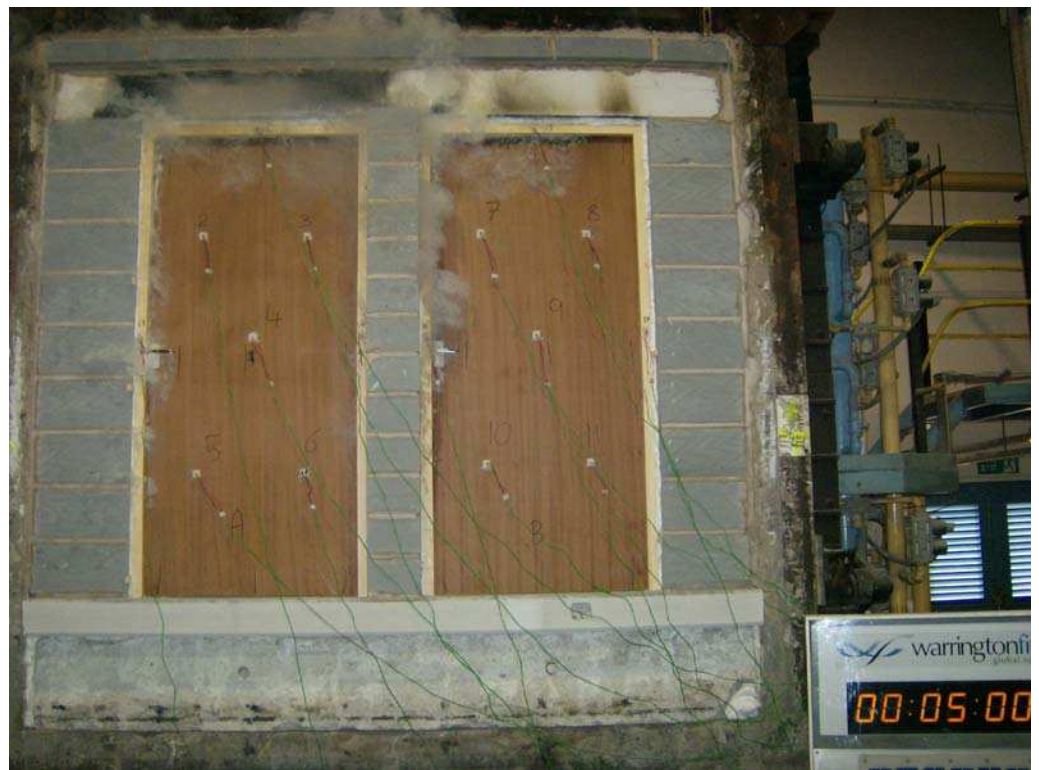
The unexposed face of the doorsets after 5 minutes of testing

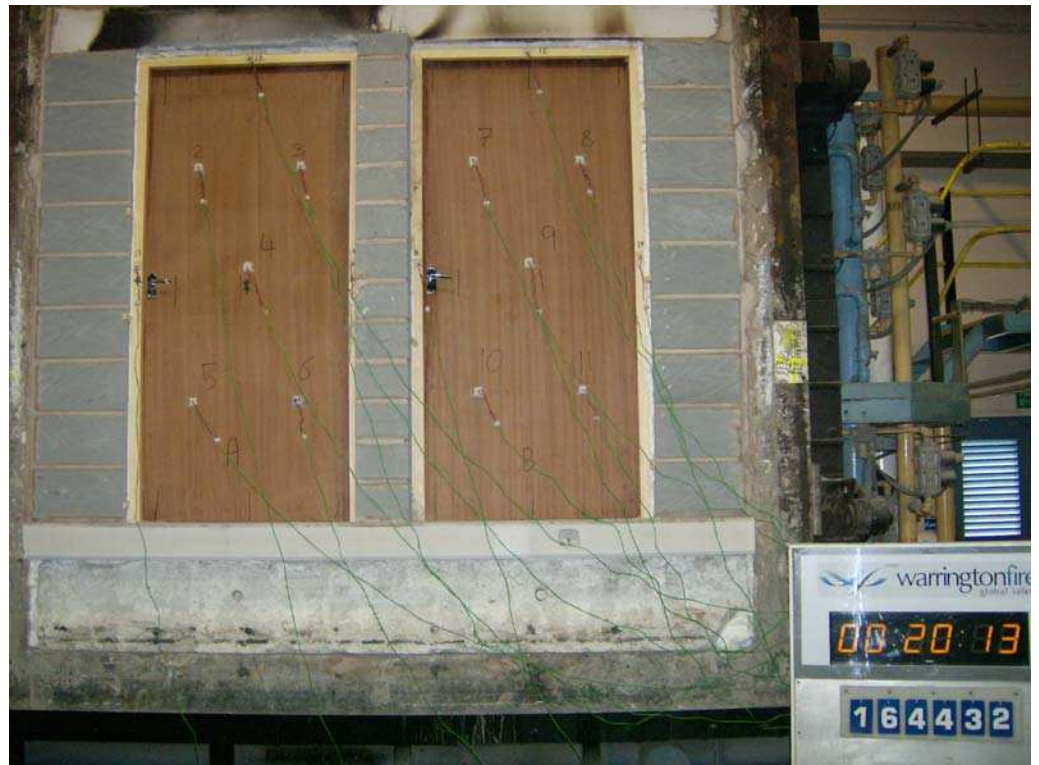
The unexposed face of the doorsets after 20 minutes of testing

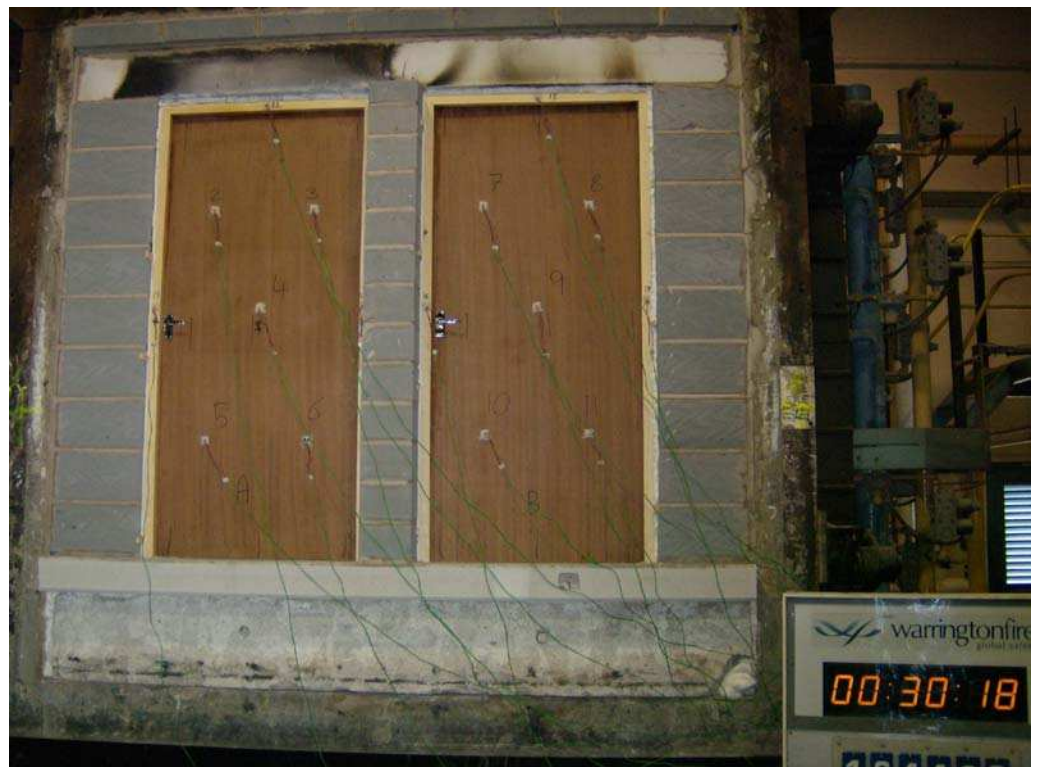
The unexposed face of the doorsets after 30 minutes of testing

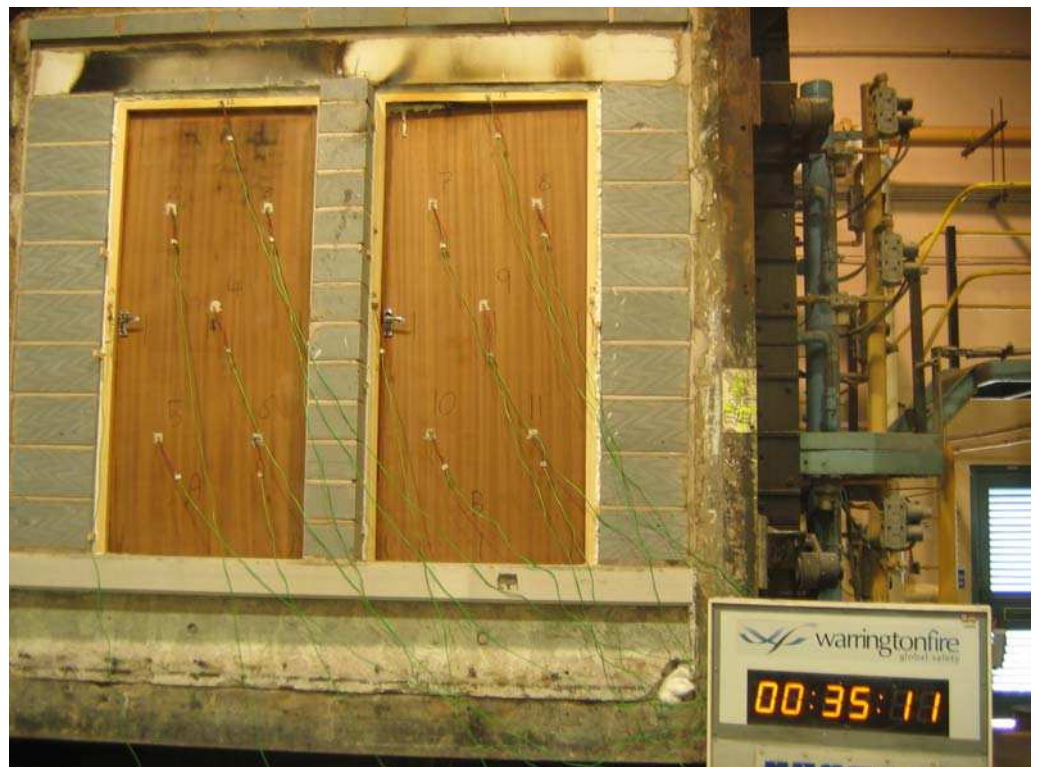
The unexposed face of the doorsets after 35 minutes of testing

| <b>35</b> | <b>00</b> | The discolouration mentioned at 34 minutes spreads downwards over the top 3 <sup>rd</sup> of the leaf of Doorset A. The facing begins to blister. |

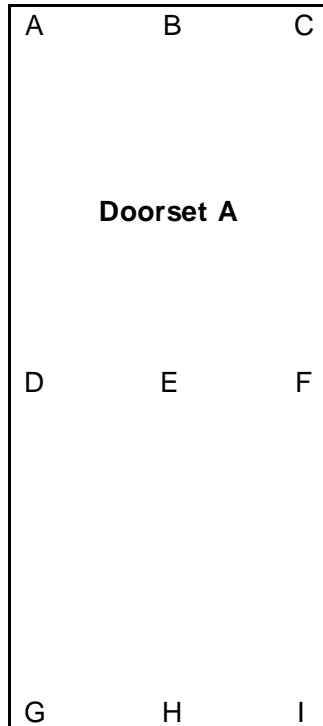
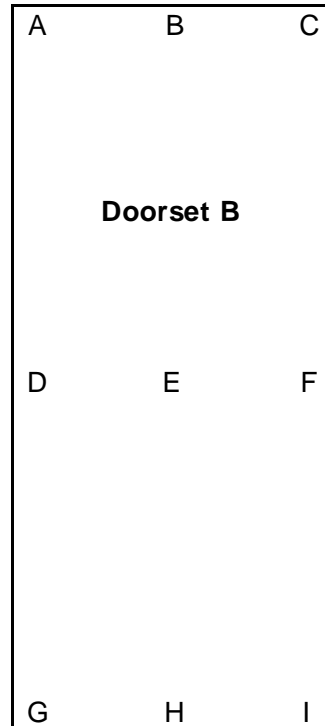
**Deflection Of The Door Leaves During The Test**

<b>Doorset A</b>									
Deflections – mm									
TIME mins	A	B	C	D	E	F	G	H	I
0	0	0	0	0	0	0	0	0	0
5	-1	-2	-1	-1	-2	1	-4	-2	0
10	0	-1	0	0	4	2	-3	-2	0
15	4	1	1	5	12	5	0	-2	1
20	6	4	4	12	21	7	1	-2	1
25	6	2	0	11	13	5	-1	-3	-1

<b>Doorset B</b>									
Deflections – mm									
TIME mins	A	B	C	D	E	F	G	H	I
0	0	0	0	0	0	0	0	0	0
5	-3	0	0	3	4	2	-1	-1	-1
10	1	3	3	9	14	4	0	-1	0
15	5	8	7	17	25	7	2	0	0
20	8	12	10	26	33	8	5	1	1
25	8	10	7	24	31	4	4	-2	-3

Positive values indicate movement towards the furnace

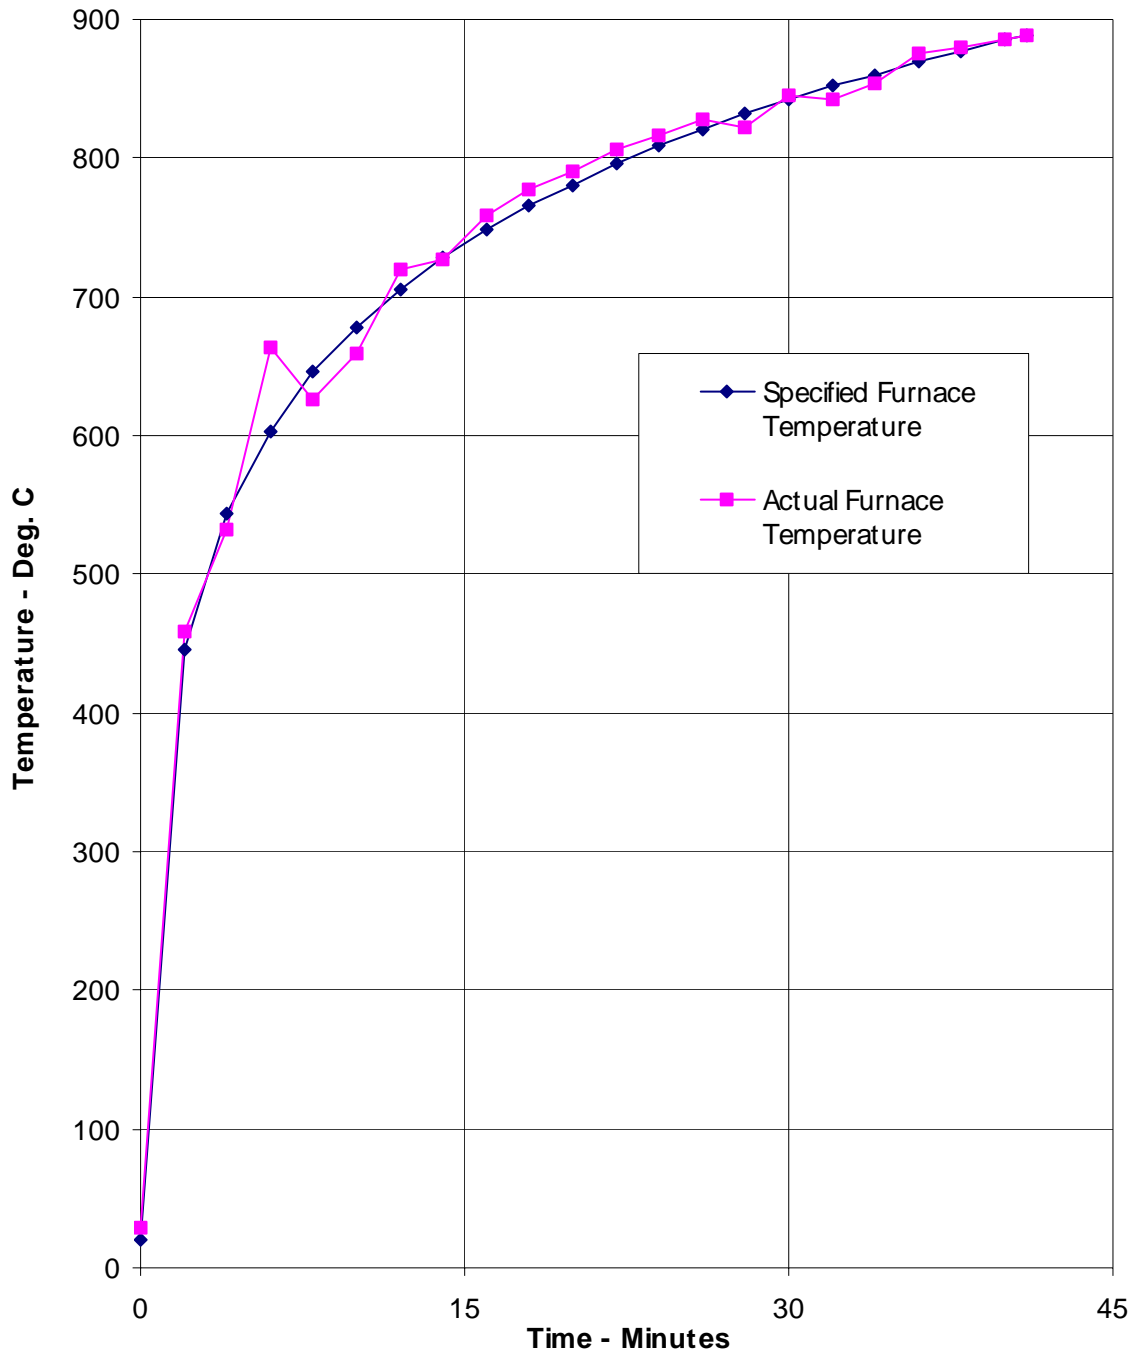
**Graph Showing Mean Furnace Temperature, Together With The Temperature/ Time Relationship Specified In The Standard**

Time Mins	Specified Furnace Temperature Deg. C	Actual Furnace Temperature Deg. C
0	20	29
2	445	459
4	544	532
6	603	663
8	646	626
10	678	659
12	706	720
14	728	727
16	748	759
18	766	777
20	781	790
22	796	806
24	809	816
26	820	828
28	832	822
30	842	845
32	852	842
34	860	854
36	869	875
38	877	880
40	885	885
41	888	889

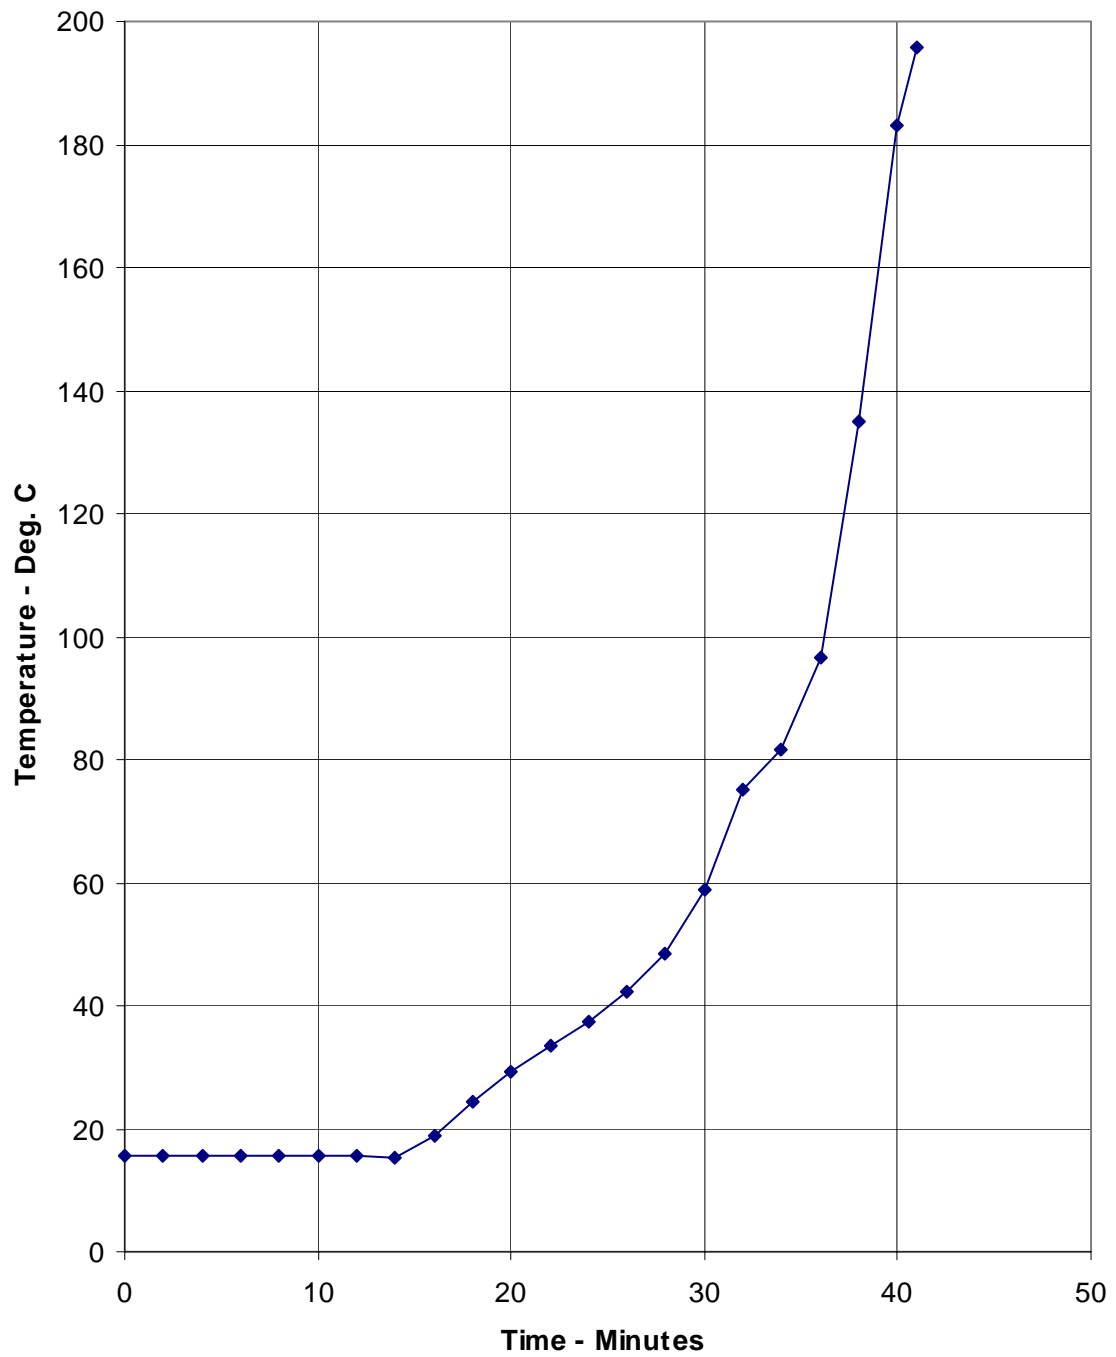
Graph Showing Mean Temperatures Recorded On The Unexposed Surface Of Doorset A

Time Mins	T/C Number 2 Deg. C	T/C Number 3 Deg. C	T/C Number 4 Deg. C	T/C Number 5 Deg. C	T/C Number 6 Deg. C	Mean Temp. Deg. C
0	15	15	16	16	16	16
2	15	15	16	16	*	16
4	15	15	16	16		16
6	15	15	16	16		16
8	15	15	16	16		16
10	15	15	16	16		16
12	15	15	17	16		16
14	14	14	16	17		15
16	19	20	19	17		19
18	24	26	27	21		25
20	29	30	32	26		29
22	33	35	36	30		34
24	37	40	38	34		37
26	43	47	41	38		42
28	48	54	48	44		49
30	58	67	57	53		59
32	79	82	77	63		75
34	75	83	81	87		82
36	102	109	91	84		97
38	145	151	130	114		135
40	194	189	183	167		183
41	191	190	207	195		196

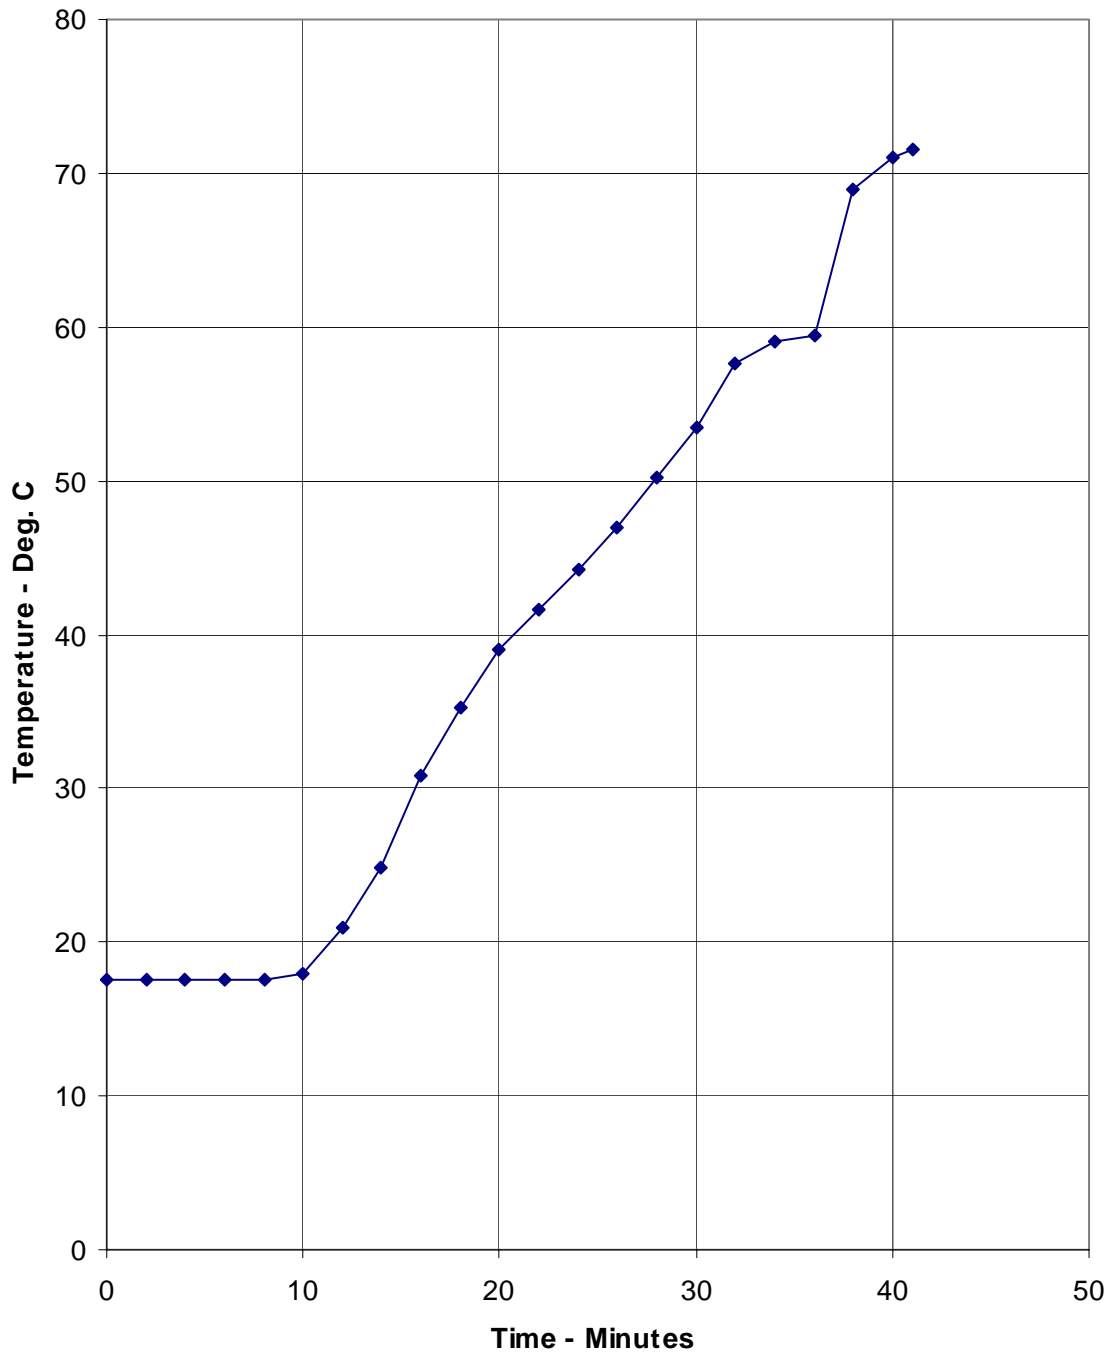
Graph Showing Mean Temperatures Recorded On The Unexposed Surface Of Doorset B

Time Mins	T/C Number 7 Deg. C	T/C Number 8 Deg. C	T/C Number 9 Deg. C	T/C Number 10 Deg. C	T/C Number 11 Deg. C	Mean Temp. Deg. C
0	16	18	18	18	18	18
2	16	18	18	18	18	18
4	16	18	18	18	18	18
6	16	18	18	18	18	18
8	16	18	18	18	18	18
10	16	19	18	18	19	18
12	19	20	21	22	23	21
14	23	23	26	25	27	25
16	28	31	33	31	31	31
18	32	36	37	36	35	35
20	36	39	41	40	39	39
22	38	41	44	43	42	42
24	40	44	46	46	45	44
26	44	46	49	48	48	47
28	49	49	51	51	51	50
30	55	51	53	54	54	53
32	58	56	57	58	59	58
34	52	58	62	*	64	59
36	49	60	63		66	60
38	63	74	71		68	69
40	62	73	70		79	71
41	64	73	72		77	72
