C A M B R I D G E
FIRE RESEARCH

REPORT NUMBER
CFR1002031

FIRE RESISTANCE TEST
IN ACCORDANCE WITH BS 476: PART 22: 1987

<p>Summary of test specimen: Partially insulated single acting glazed double leaf timber doorset.</p> <p>Left leaf size: 2100 high x 927 wide x 54 thick overall Right leaf size: 2100 high x 926 wide x 54 thick overall</p>
---	--

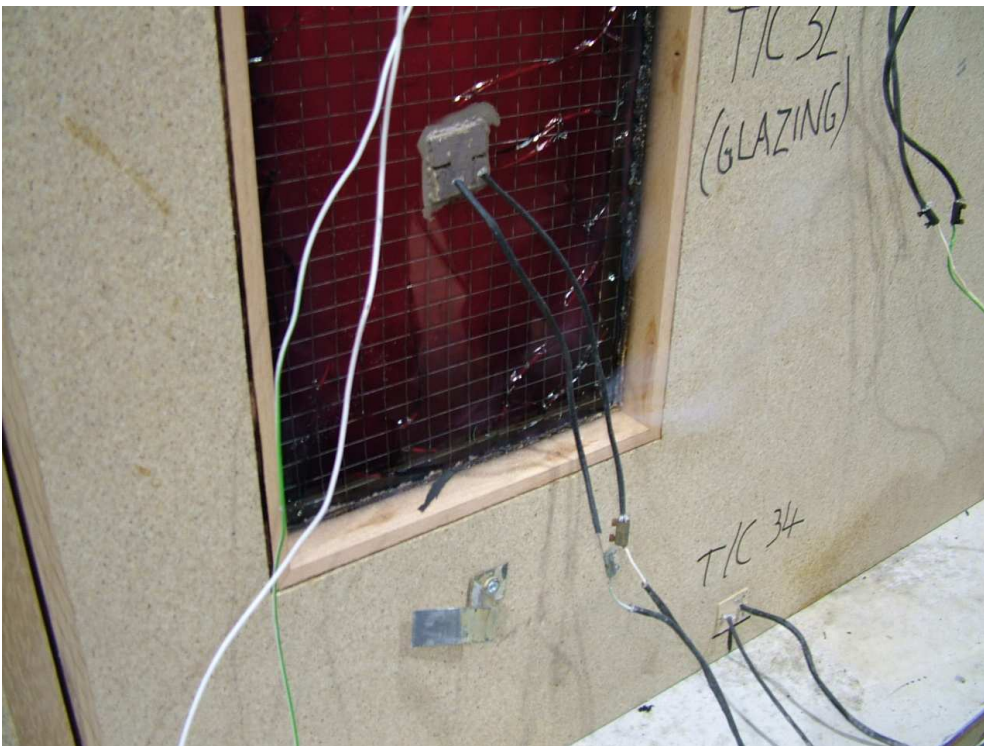
Photo 2.2.6 – After 21 minutes.

20:00	U	Smoke/steam issues at the beading to leaf interface of all the glazing apertures. Staining is apparent above all the glazing apertures.
22:00	U	Smoke/steam issuing at the meeting stiles and across the head of both leaves has increased in density. The exposed face top glazing bead of the top glazing aperture of the left hand leaf has detached.
