The fire resistance performance of a double leaf single acting doorset with glazing when tested in accordance with BS EN 1634-1: 2014 and BS EN 1363-1: 2012

BMT/FEP/F16079

A double leaf single acting doorset with glazing opening in towards the furnace

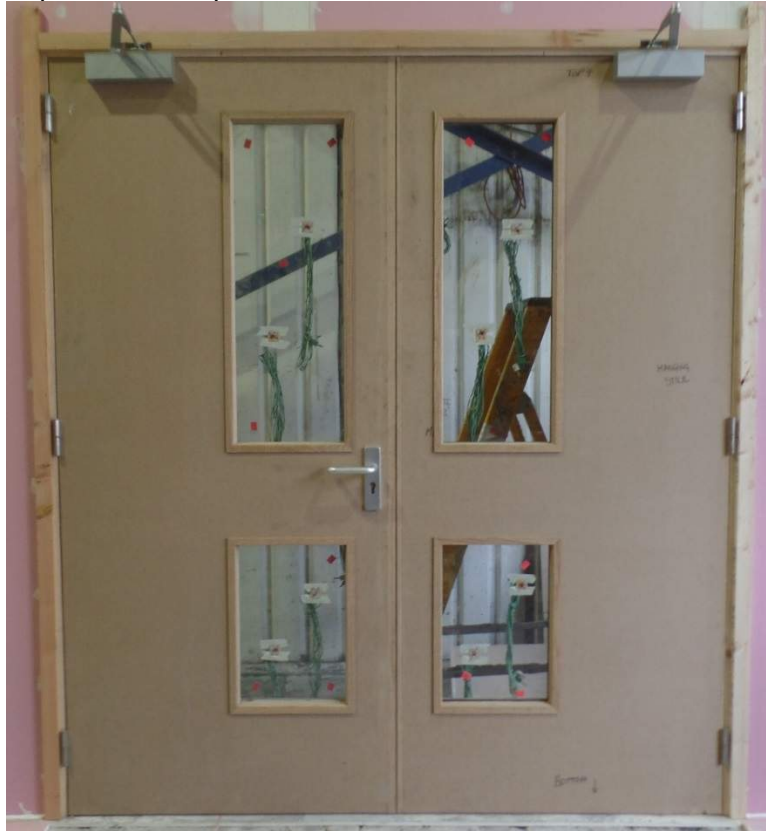
Exposed face – pre test

Leaf size – both leaves: 2132mm high x 947mm wide x 54mm thick

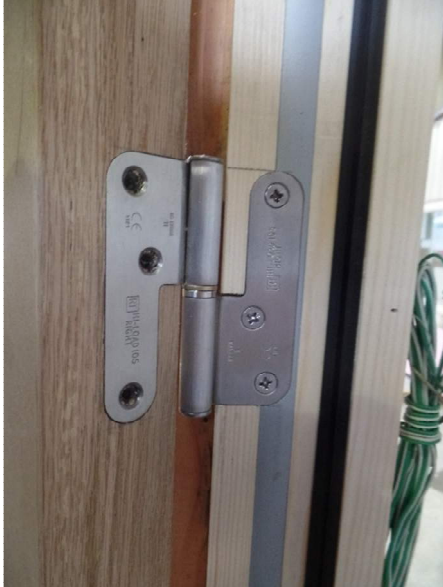
Around hinge blade

### Intumescent interruptions by hardware
